NSWC/DL-TR-79/86

# EDDY CURRENT TESTING AND ULTRASONIC REFERENCE STANDARDS FOR DEPLETED URANIUM BARSTOCK

by  
C. W. ANDERSON  
Weapons Systems Department

MARCH 1978

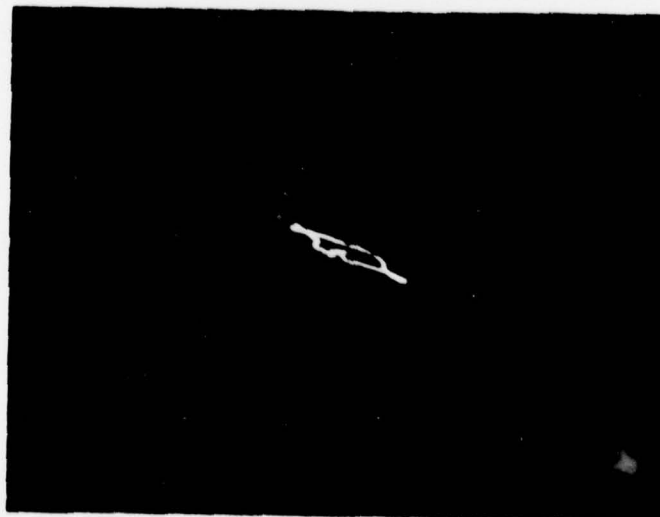
PHD-0618-2-79      Figure 15.  
Eddy Current Indication Caused by  
.020" Deep Notch in Test Standard

the horizontal direction. Figure 15 shows the CRT indication caused by a .020" deep notch machined into the bar surface. Notice the indication has a vertical component in both the up and the down directions causing a "Figure 8" type of indication. This is caused by the defect passing from one coil to the next. The indication is reversed depending on which coil contains the defect at a particular instant. Figure 16 shows the indication caused by a naturally occurring defect. This is the same defect which was not detected by the ultrasonic technique.

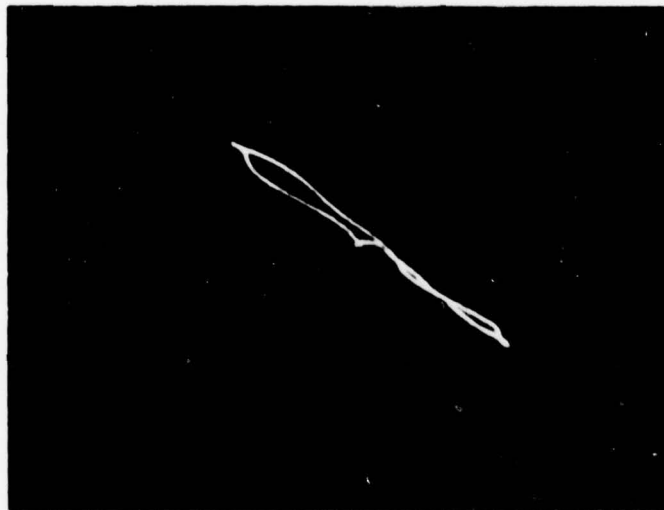
PHD-0619-2+79      Figure 16.  
Eddy Current Indication Caused by  
Naturally Occuring Flaw
